# Manhole Inspection Summary

Manhole # S150\_\_030MH

Insp Date: **4/7/08 10:08 AM**

**Location** Address: **2661 dulany-lehman alley**

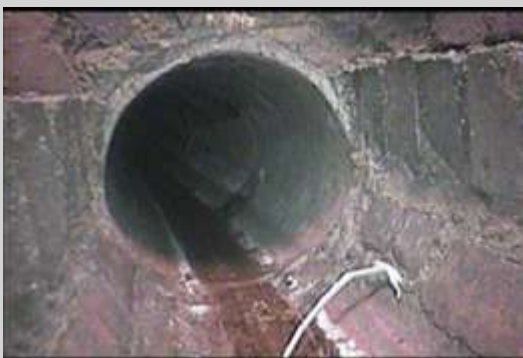
6 O'Clock Inflow

8 in. Circular Gravity Sewer  
Pipe In @ 6 O'Clock

Pipe Height: **8.4** (in.) Rod and Bar (Angled)  
Pipe Material: **Clay** ☐ Pipe Lined  
Invert Depth: **6.74** (ft.) Flow Characteristics: **Slow**  
Deposits: ☒ None ☐ Mud ☐ Sludge ☐ Debris ☐ Grease  
Silt Depth: **0** (in.) Deposits Extent:  
Infiltration: **None** Pipe Seal Cond: **Sound**
